Case Study 3: Contaminated Ileostomy Site

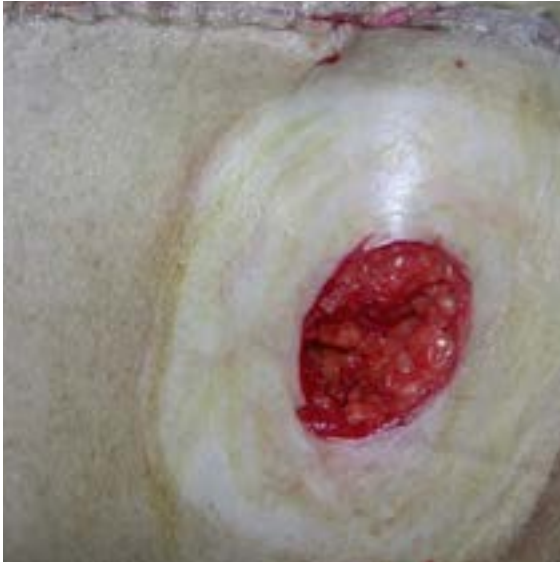
A. Immediate postoperative, right lower quadrant wound

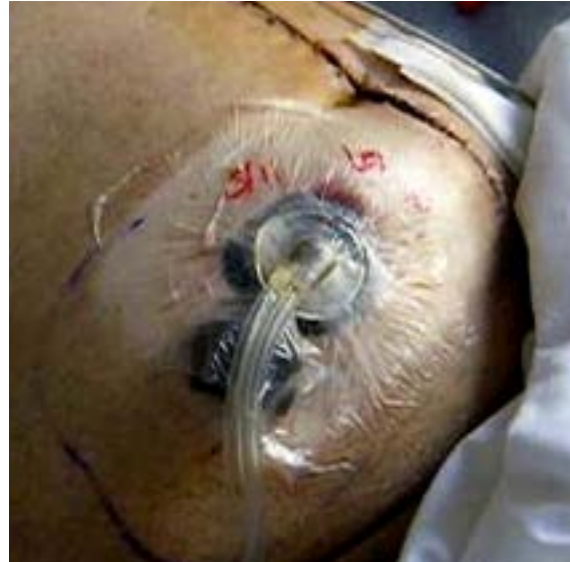
B. Application of V.A.C. VeraFlo™ Therapy with instillation of Microcyn®

An 83-year-old male presented with an open postoperative contaminated wound at a previous ileostomy site. V.A.C. VeraFlo™ Therapy was initiated using V.A.C. VeraFlo™ Dressing. Microcyn® (Oculus Innovative Sciences, Petaluma, CA) was instilled until the foam was filled followed by a soak time of 10 minutes. Instillation was repeated every 4 hours followed with continuous negative pressure at -125 mmHg for 12 days. Therapy was discontinued when patient transitioned out of the acute care setting and the wound could be treated with local wound care alone. No complications occurred during therapy.

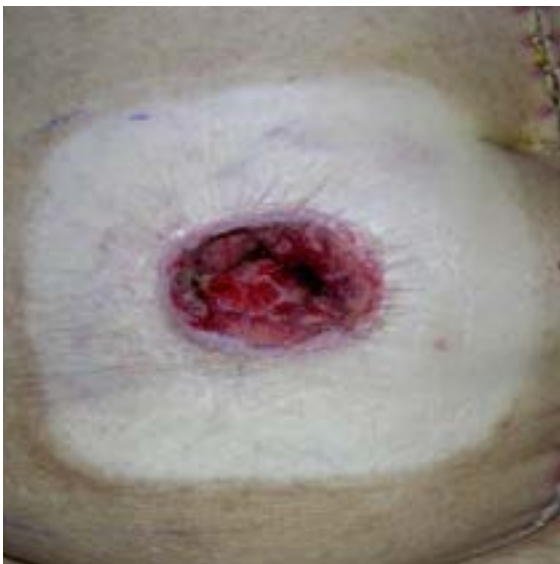
C. Day 10 of V.A.C. VeraFlo™ Therapy at 4th dressing change

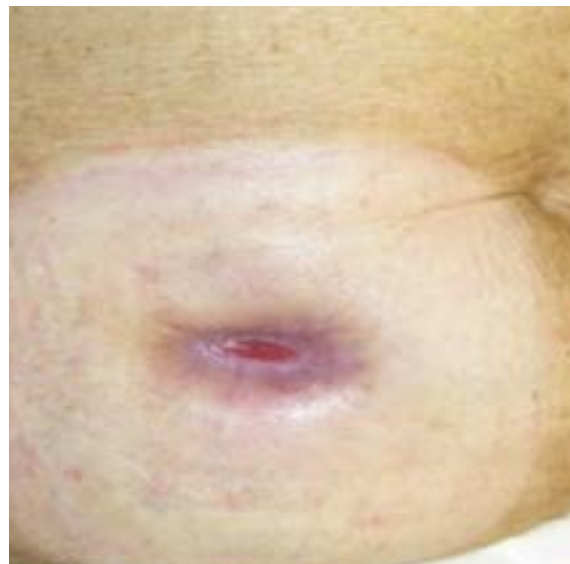
D. Follow up on postoperative Day 34
